Effect of Moisture on Fatigue Crack Growth of Age-Hardened Al Alloy

ABSTRACT: The effect of moisture on the growth behavior of a fatigue crack was investigated for an extruded bar of age-hardened Al-Zn-Mg-Cu alloy (7075-T6) in relative humidity of 25% and 85% at frequencies of 50 Hz and 6 Hz under rotating bending. Fracture in high humidity was a shear mode in short life region and a tensile one in long life region at 50 Hz, though all the fractures were a tensile one in low humidity. Fracture surface was covered with many slip planes and voids in the shear mode fracture, while a few brittle facets were observed in addition to striations in high humidity. On the other hand, at 6 Hz in high humidity, fracture occurred in the tensile mode with striations and brittle facets even in short life region. The difference in fracture mechanism depending on the fatigue life and frequency was explained from the difference in amount of hydrogen generated by the reaction of aluminum with water vapor.

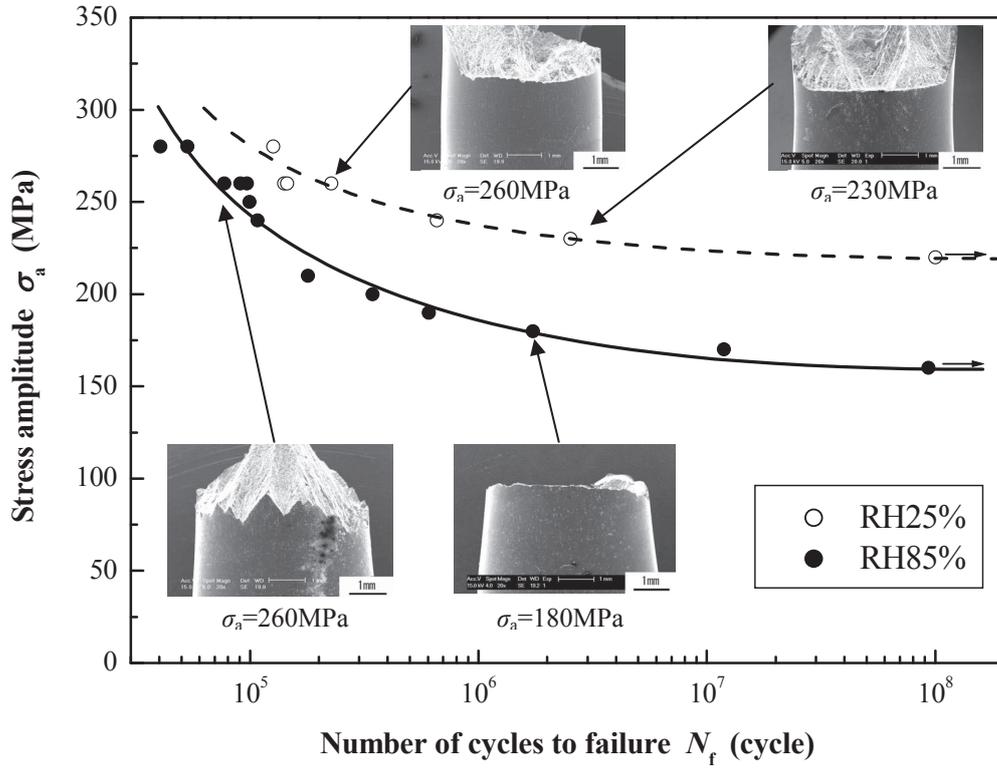
Fig. 1: S-N curves and macroscopic appearance of fracture at 50 Hz

Figure 1 shows $S-N$ curves in constant humidity of 25% and 85% at 60 Hz. In the figure, typical crack morphologies at low and high stress levels are also shown. Fatigue strength was decreased by high humidity. Fatigue strength at 10^7 in 85% decreased to about 70% in comparison with that in 25%.

Macroscopic appearances of fractures are a shear mode at high stress levels in high humidity, though those are a tensile mode in other conditions of humidity and stress level.

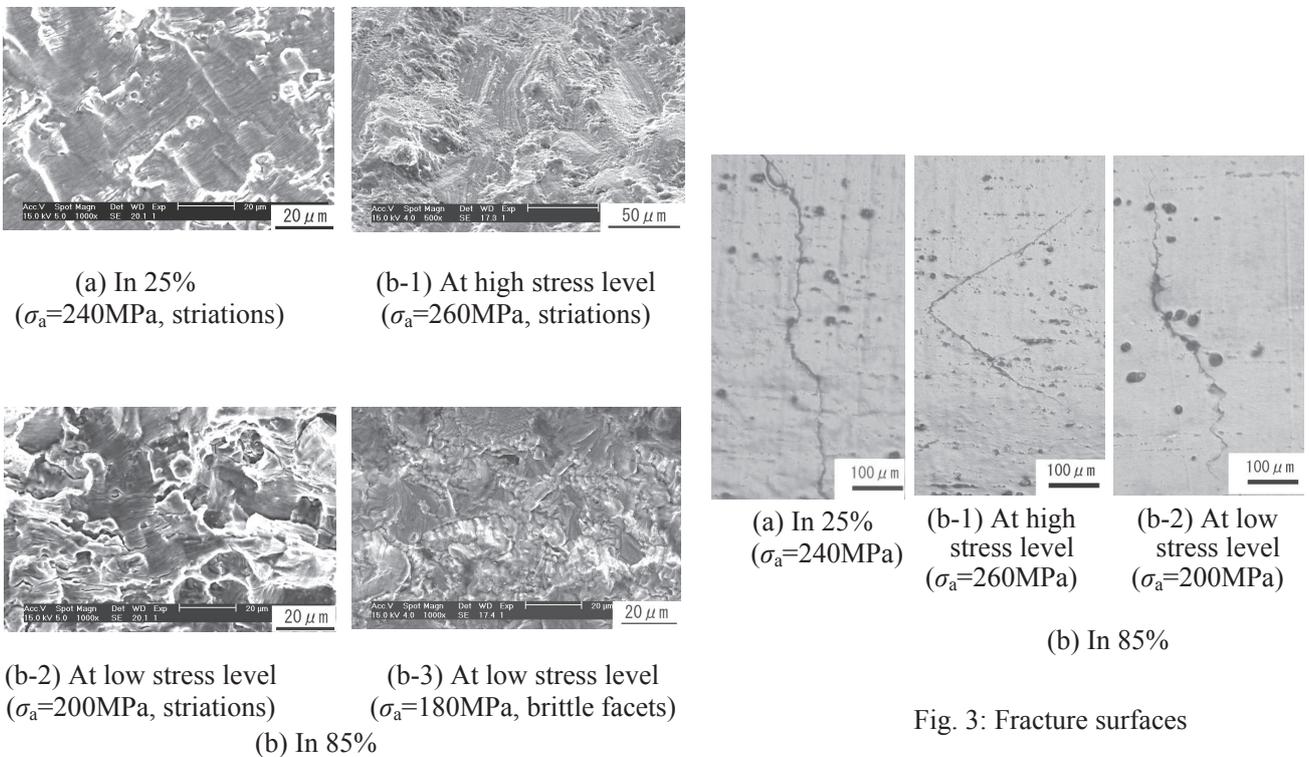
Fig. 2: Fracture surfaces

Figure 2 shows fracture surfaces yielded by the shear mode crack and the tensile one. Fracture surface was covered with many slip planes and voids in the shear mode fracture, while it was with striations in the tensile mode fracture. In addition, a few brittle facets are also observed at low stress levels in high humidity. The fracture surface yielded by the shear mode crack was a (100) plane which was confirmed by etch pit method.

Figures 5 and 6 show morphologies of cracks and fracture surfaces in high humidity at stress level where the shear mode fracture occurred at high frequency. In case of the low frequency test, a crack propagates in a zigzag manner and a few brittle facets are observed in addition to striations at fracture surface similar to the results at low stress levels in high humidity at 50 Hz as shown in Fig.2 (b-3).

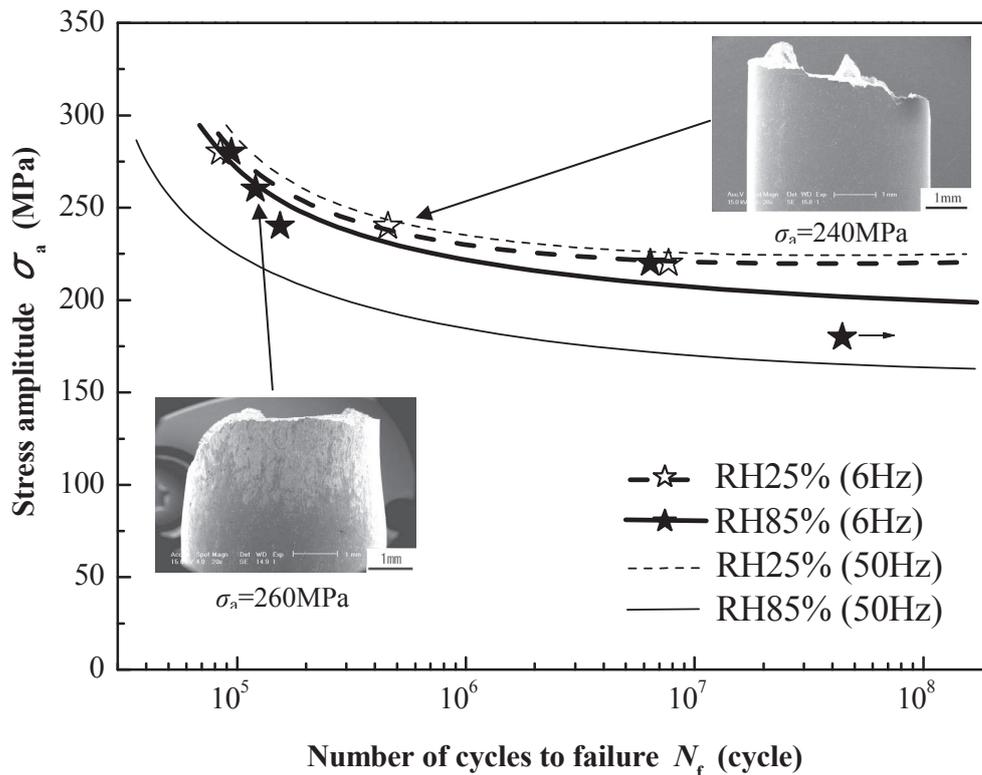
Fig. 4: S - N curves and macroscopic appearance of fracture at 6 Hz

Figure 4 shows S - N curves and typical fracture morphologies at 6 Hz. In the figure, S - N curves at 50 Hz are also indicated by lines only. The tests at low frequency were carried out to investigate the effect of

exposure time in high humidity. As well known, there is no or little influence of frequency on fatigue life in low humidity. While, in high humidity, fatigue life at low frequency was larger than that at high frequency in spite of decrease in crack initiation life due to longer exposure in high humidity, i.e. promotion of crack initiation by anodic dissolution. In addition, the specimen fractured in the tensile mode.

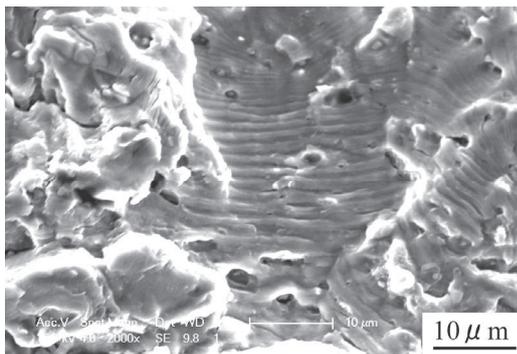
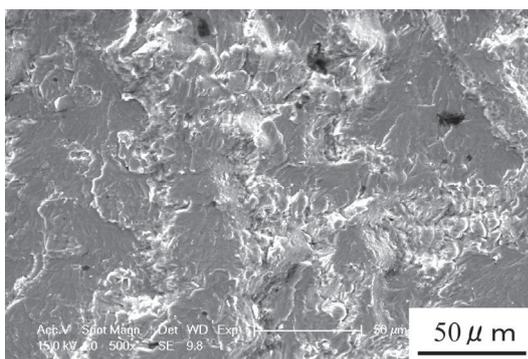
Fig. 6: Fracture surfaces in high humidity (6 Hz, $\sigma_a=280\text{MPa}$)

(a) Striations

(b) Brittle facets
